“Bringing Art Back to LIFE”

Antique Trunk Repair

Art Restoration, Repair and Conservation Services

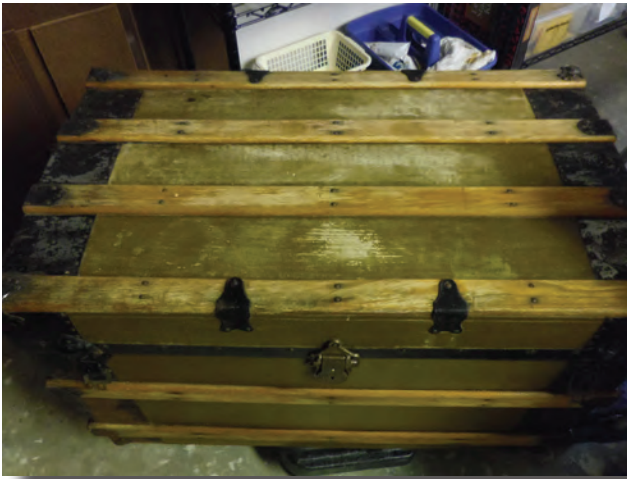
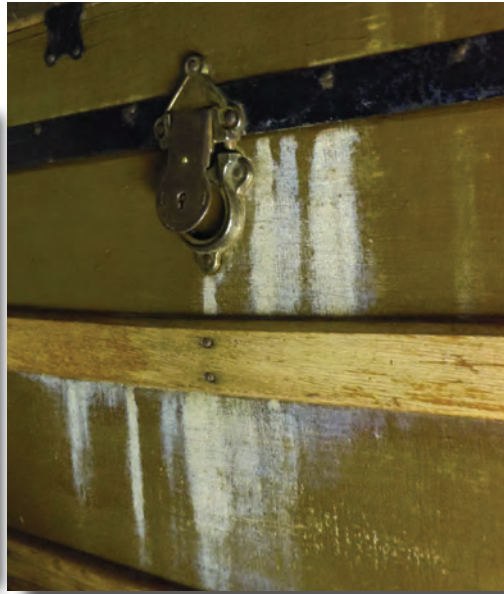
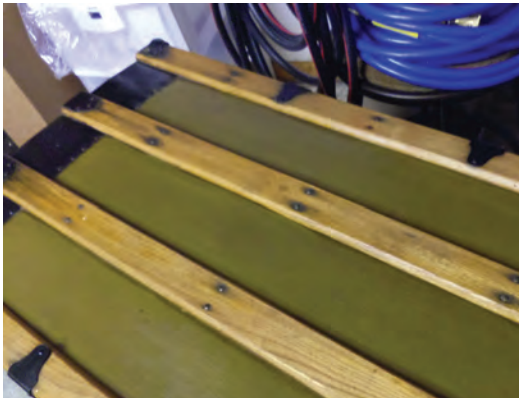
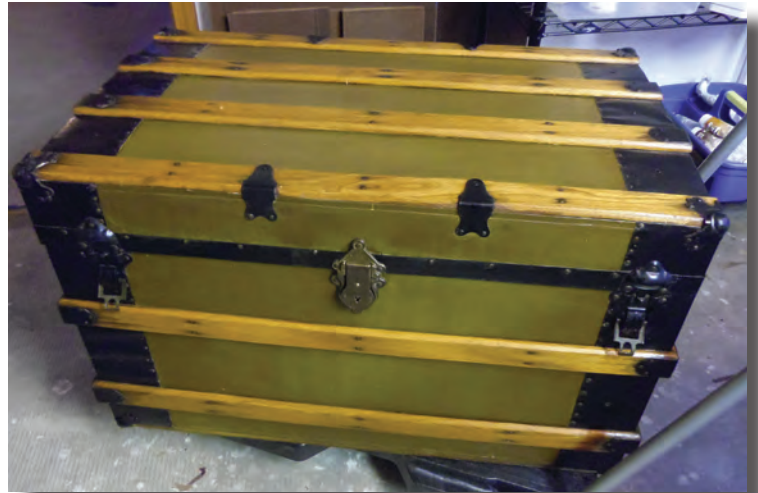
Antique Trunk Repair from Water Damage

Before additional coats of Oak Staining on trim

Water stains removed and canvas on trunk refurbished and re-tinted in ochre and refinished in umber varnish to match original. Oak Trim Slats were also restained/refinished and old dry rotted broken handles were replaced with new handles.

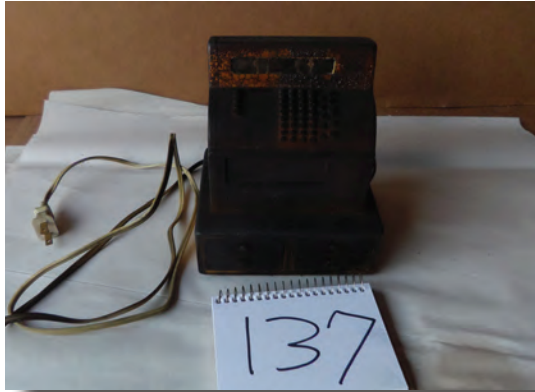
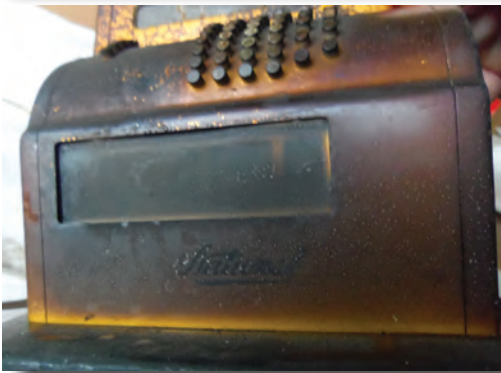
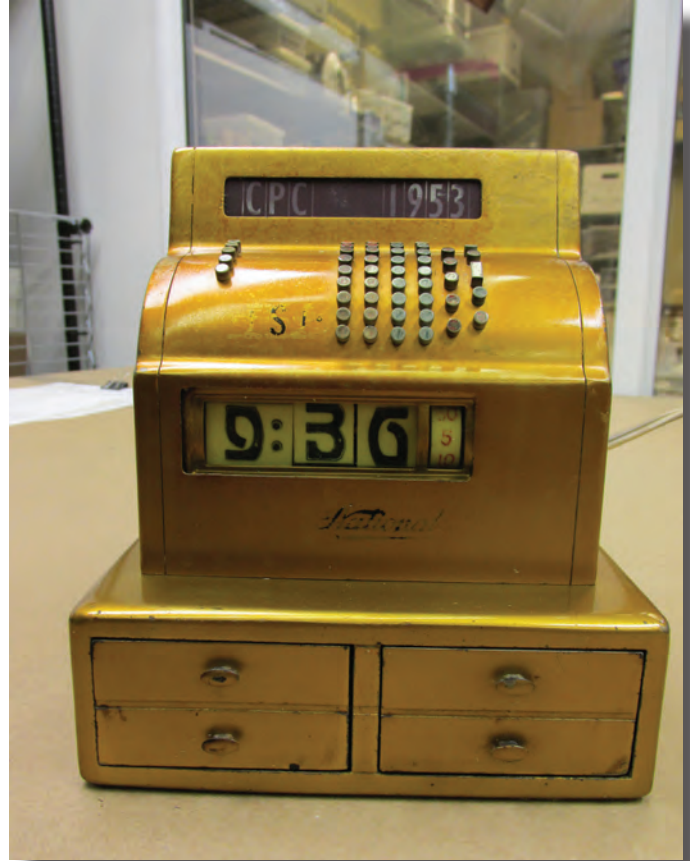
Omicron Clock Repair from Fire Damage

Damage: Finish had burned off clock due to intense heat. Glass faces were broken and burned. Lettering was damaged in areas.

Treatment Services: Removed Soot and debris retaining as much of the original finish as possible. Remove internal clock works-cleaned interior elements. Digitally remastered the runined register money screen. Re-touched missing paint with inpainting of gold metallic to match original color. Re-created new glas fronts to match originals.

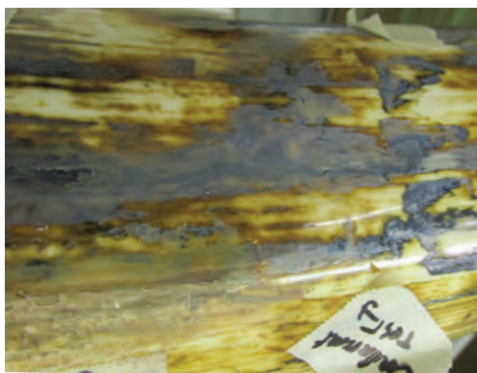
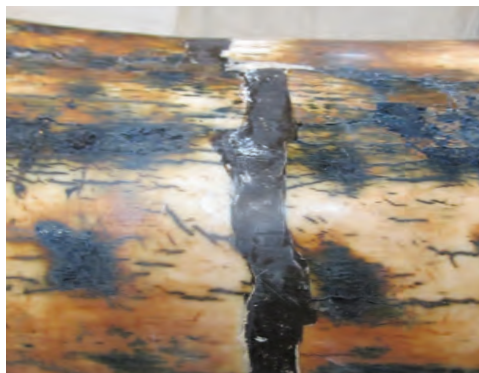
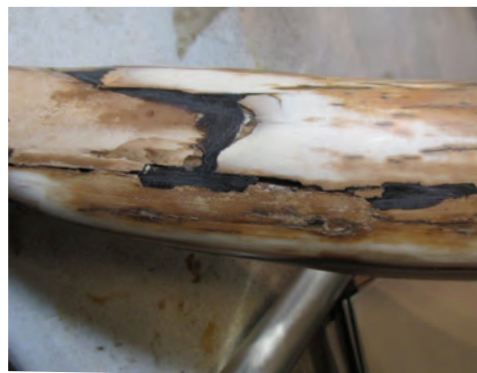
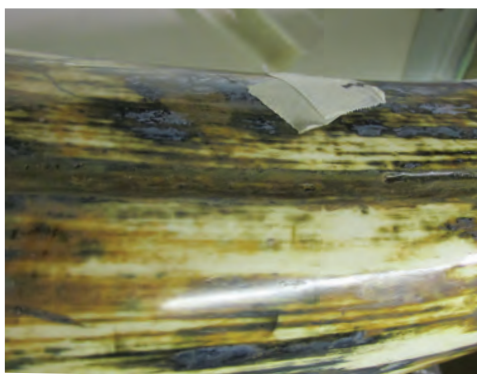
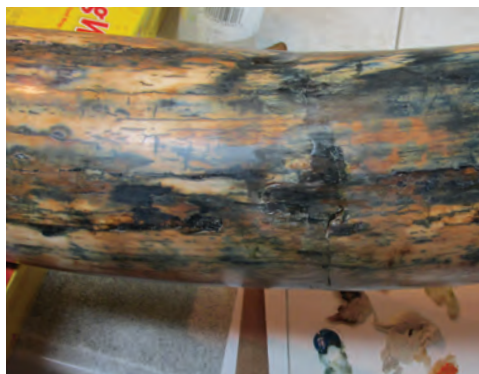
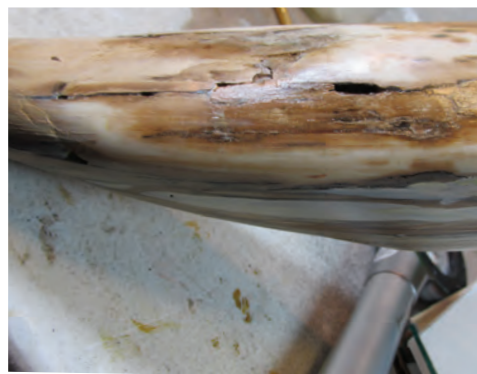
Retouching of 10,000 year old Woolly Mammoth Tusks

Damage: These pieces had cut lines from when they were harvested by the inuits from the glaciers and filled areas after they had been reconsolidated. We were asked to retouch the areas. Many of these tusks were 4-6 feet long.

Determine best methods for retouch to get the fossilized and mineral deposit look. Application of inpainting.

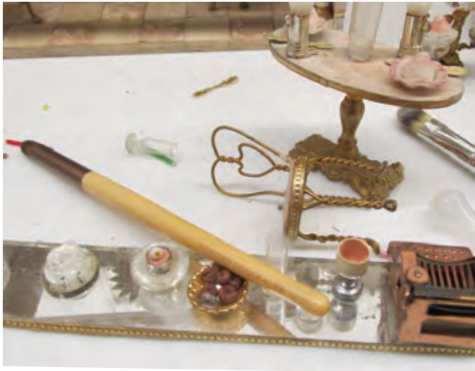
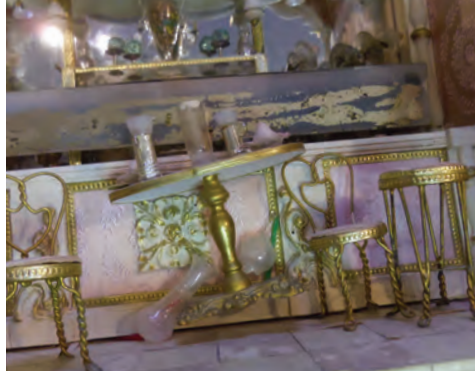
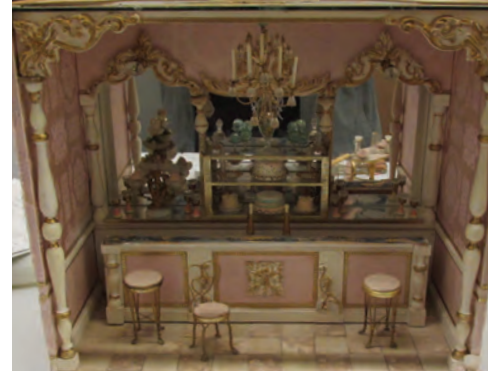
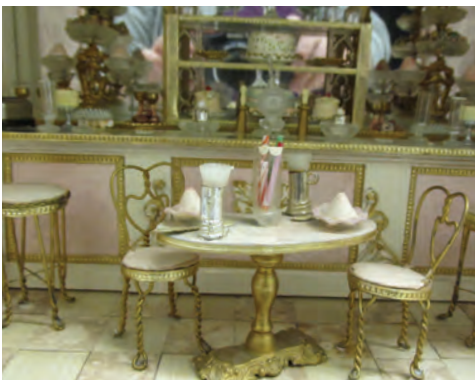
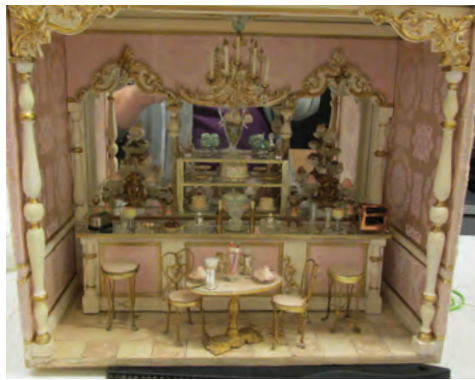
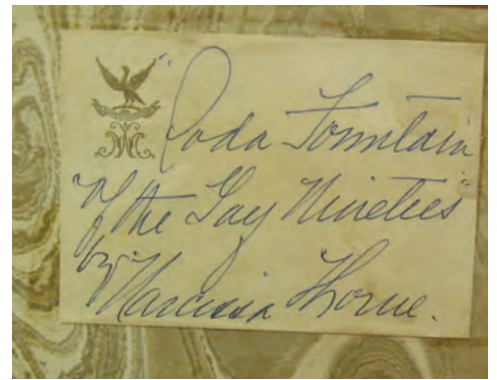
Thorne Room Minatures needing some refurbishing

Damage: Many of the internal elements are broken loose. Some breakage to pieces. Overall interior is dirty. Glass on front is broken and needs repair.

Deconstruct box carefully and reuse all original elements including original backing papers. Repair all internal elements and place back into original order. Replace glass and rebuild box using original elements.
