“Bringing Art Back to LIFE”

Antique Trunk Repair

Art Restoration, Repair and Conservation Services

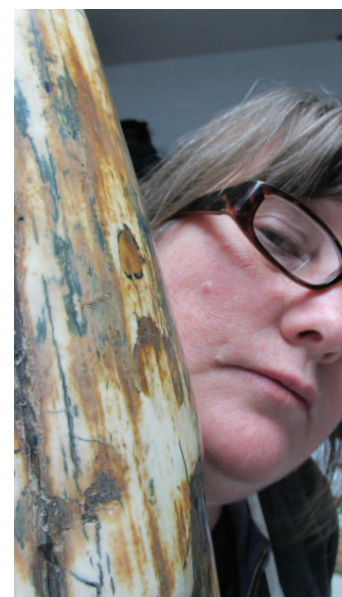
Damage: These pieces had cut lines from when they were harvested by the inuits from the glaciers and filled areas after they had been reconsolidated. We were asked to retouch the areas. Many of these tusks were 4-6 feet long.

Determine best methods for retouch to get the fossilized and mineral deposit look. Application of inpainting.
